MARYLAND HISTORICAL TRUST DETERMINATION OF ELIGIBILITY FORM

Property Name: C.P. Merrick Farm (Kevin Wayson Farm) Inventory Number: Q.A.-64
Address: 815 Brierley's Mill Road City: Barclay Zip Code: 21607
County: Queen Anne's USGS Topographic Map: Church Hill Quad
Owner: Mr. & Mrs. Kevin J. Wayson, Owings, MD Is the property being evaluated a district? No yes
Tax Parcel Number: 2 Tax Map Number: 24 Tax Account ID Number: Dist.01; # 005618
Project: Surface Mine Agency: MD Dept. of the Environment
Site visit by MHT Staff: no X yes Name: Orlando Ridout V Date: 05/13/80
Is the property located within a historic district? yes X no

MARYLAND HISTORICAL TRUST
NR-ELIBILITY REVIEW FORM

C.P. Merrick Farmhouse - Q.A. 64

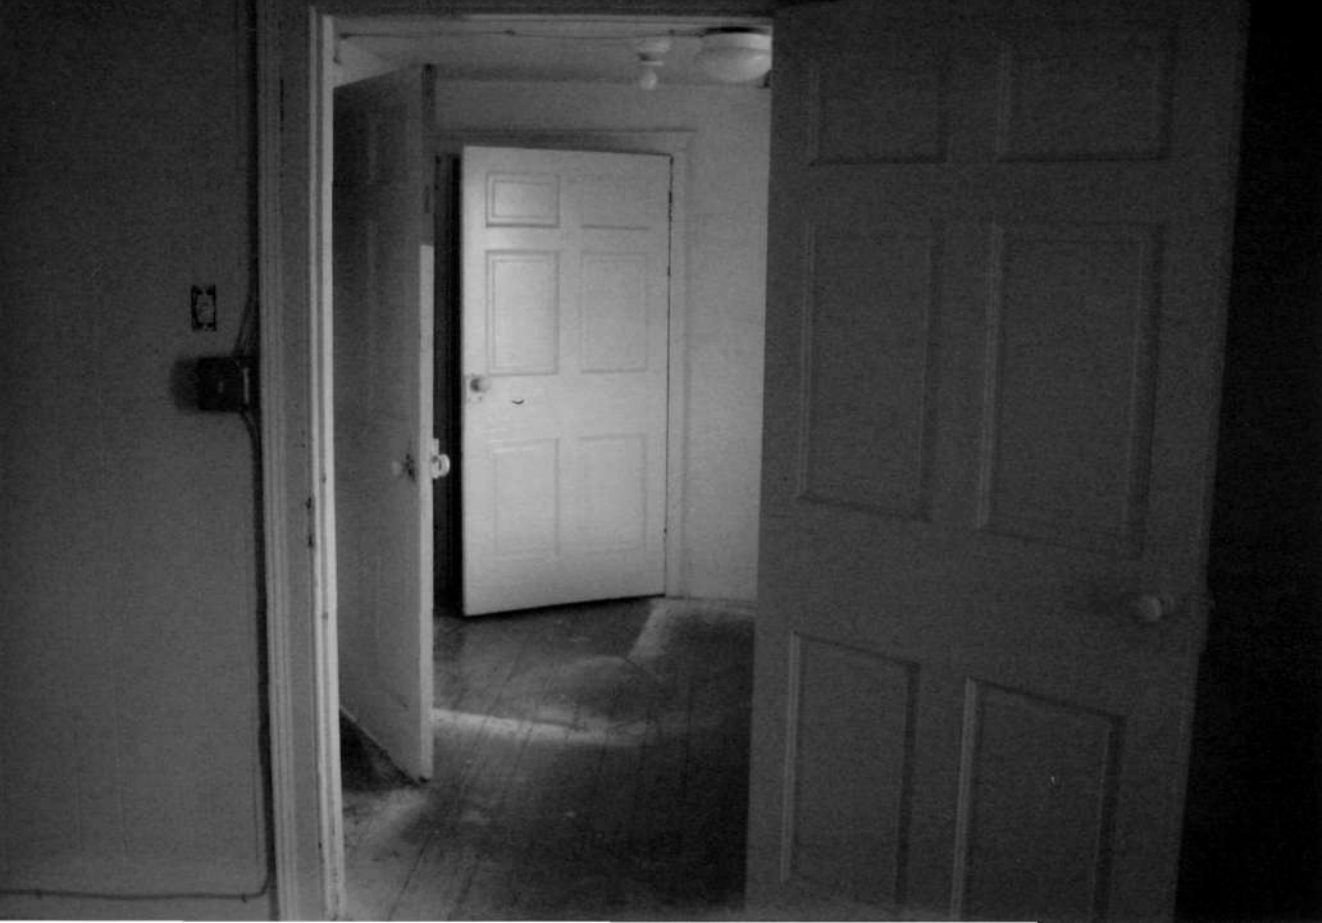
QA-0064_2010-10-26_01

View of hall from S. bedroom

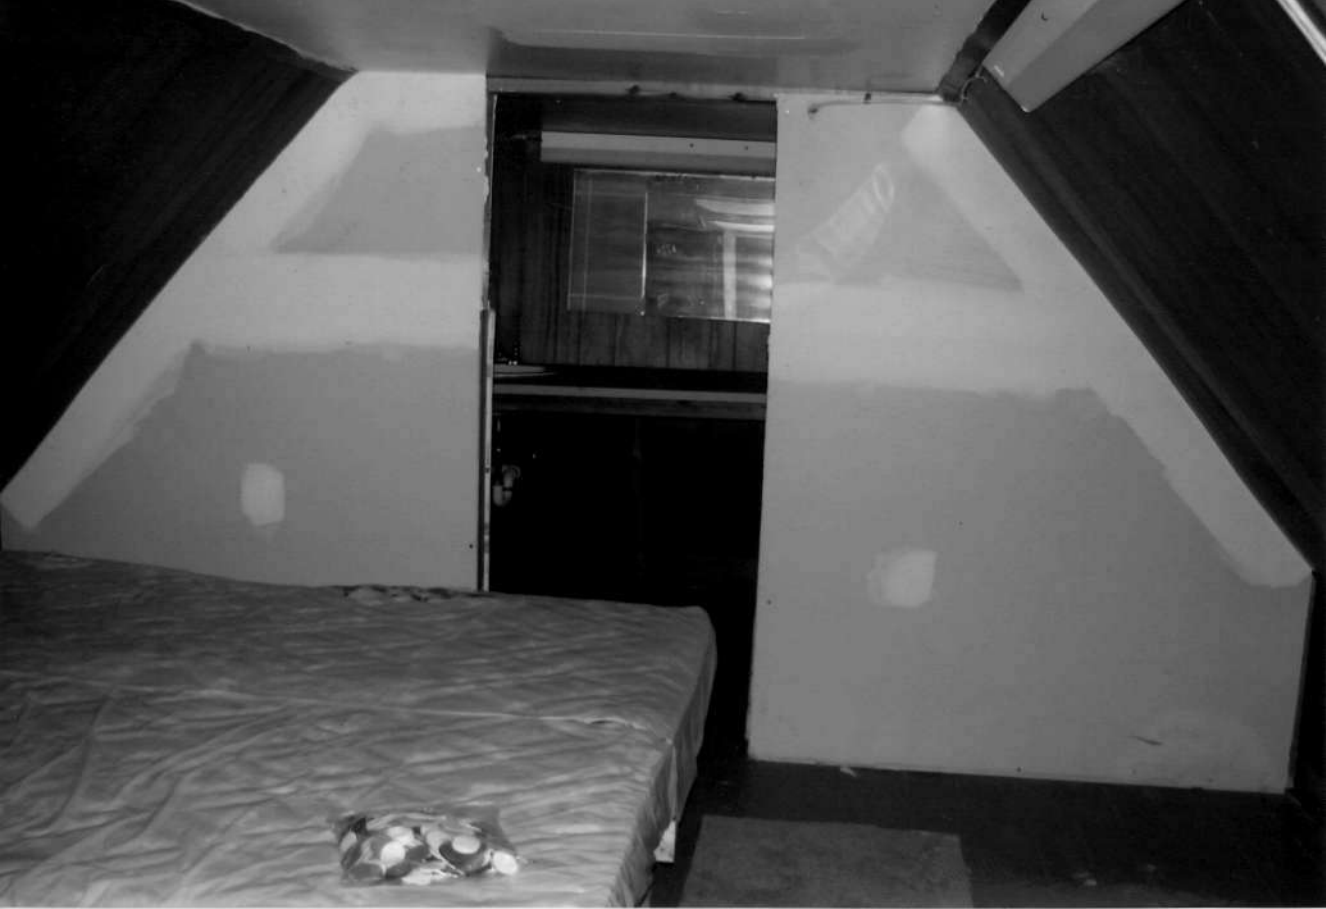
QA-0064_2010-10-26_02

Bedroom + Bath over Kitchen

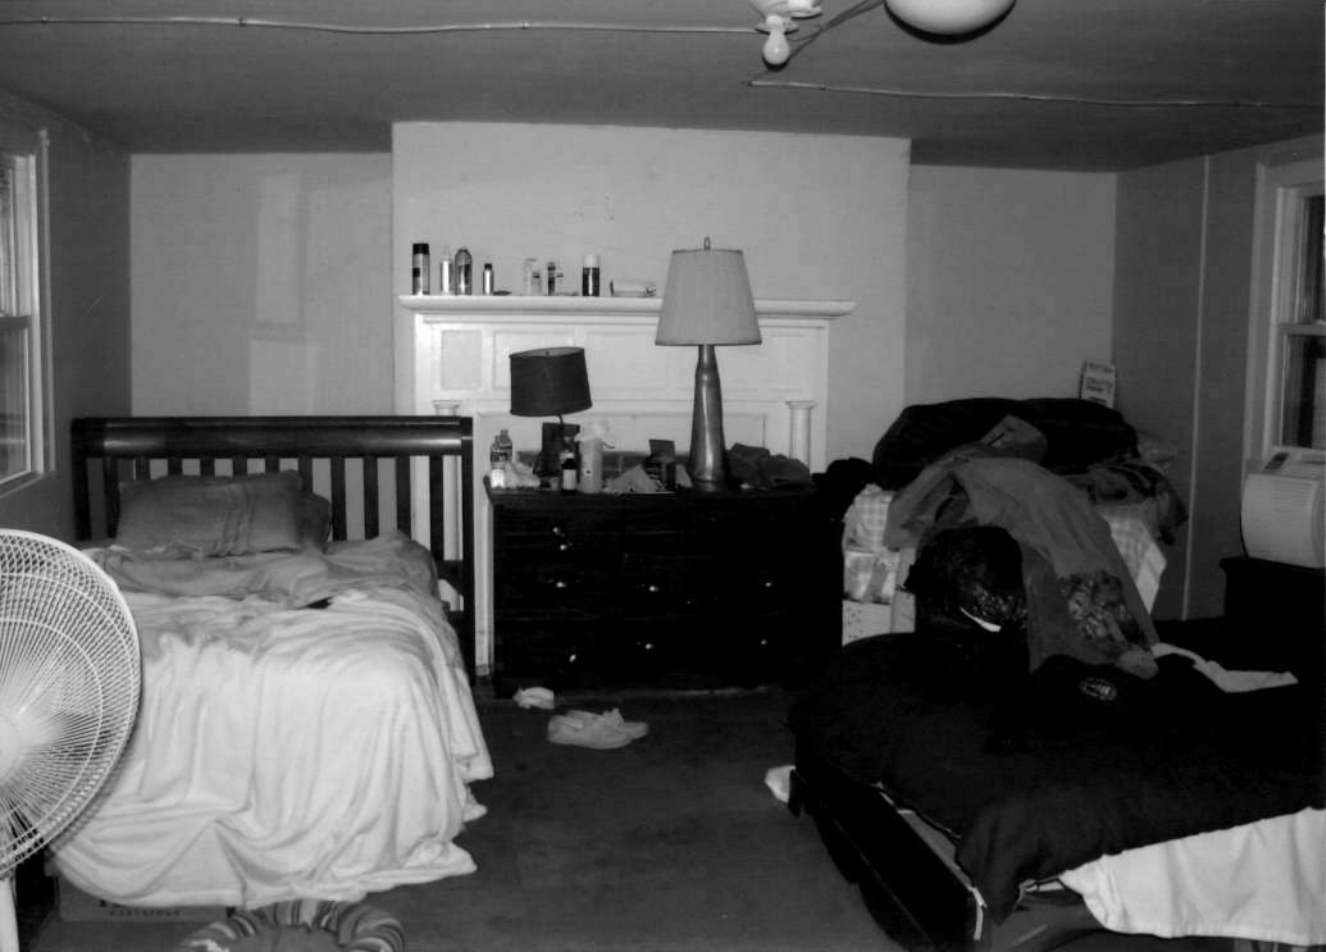
QA-0064_2010-10-26_03

There is only one room on the first floor of the gambrel room section at the south end of the building. It has an original bold Empire style mantel with plain Doric columns and a frieze of five panels, the outer panels being reeded. There are no original window moldings remaining since the windows were replaced.

Parlor bedroom

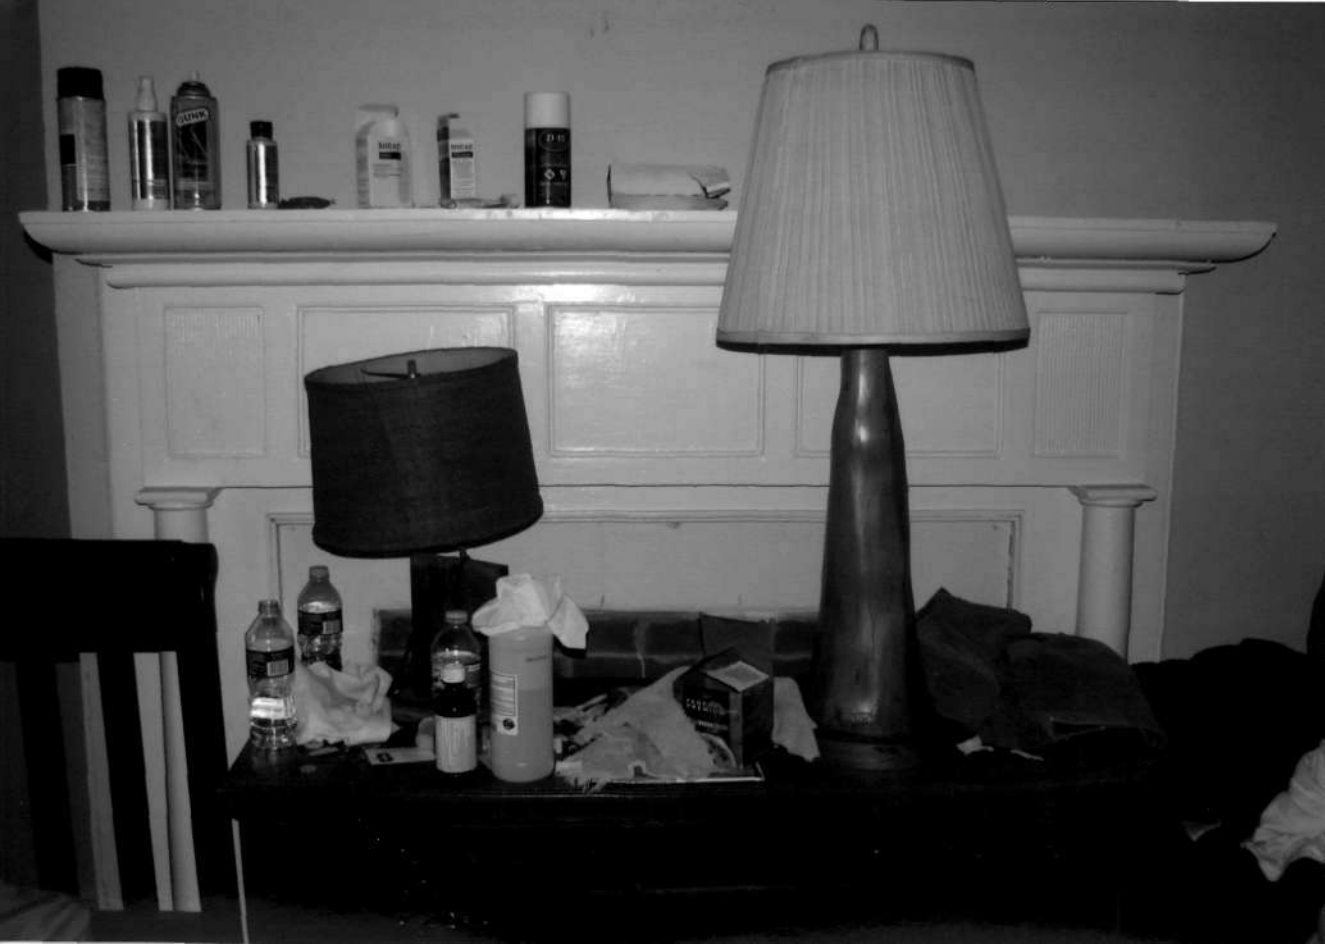
QA-0064-2010-10-26-04

Mantel Detail - Parlor bedroom

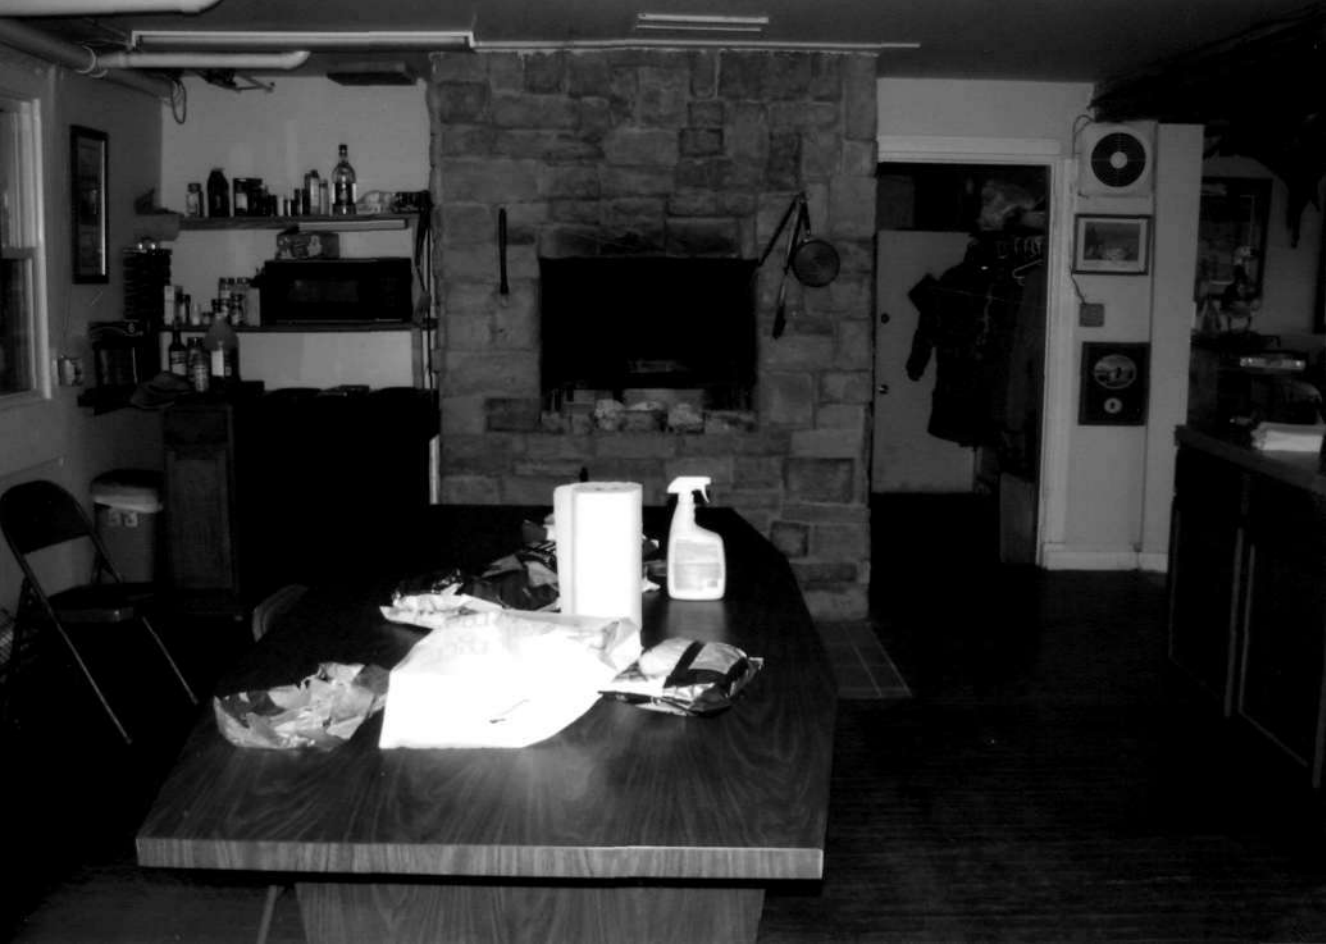
QA-0064_2010-10-26_05

View looking North in Kitchen

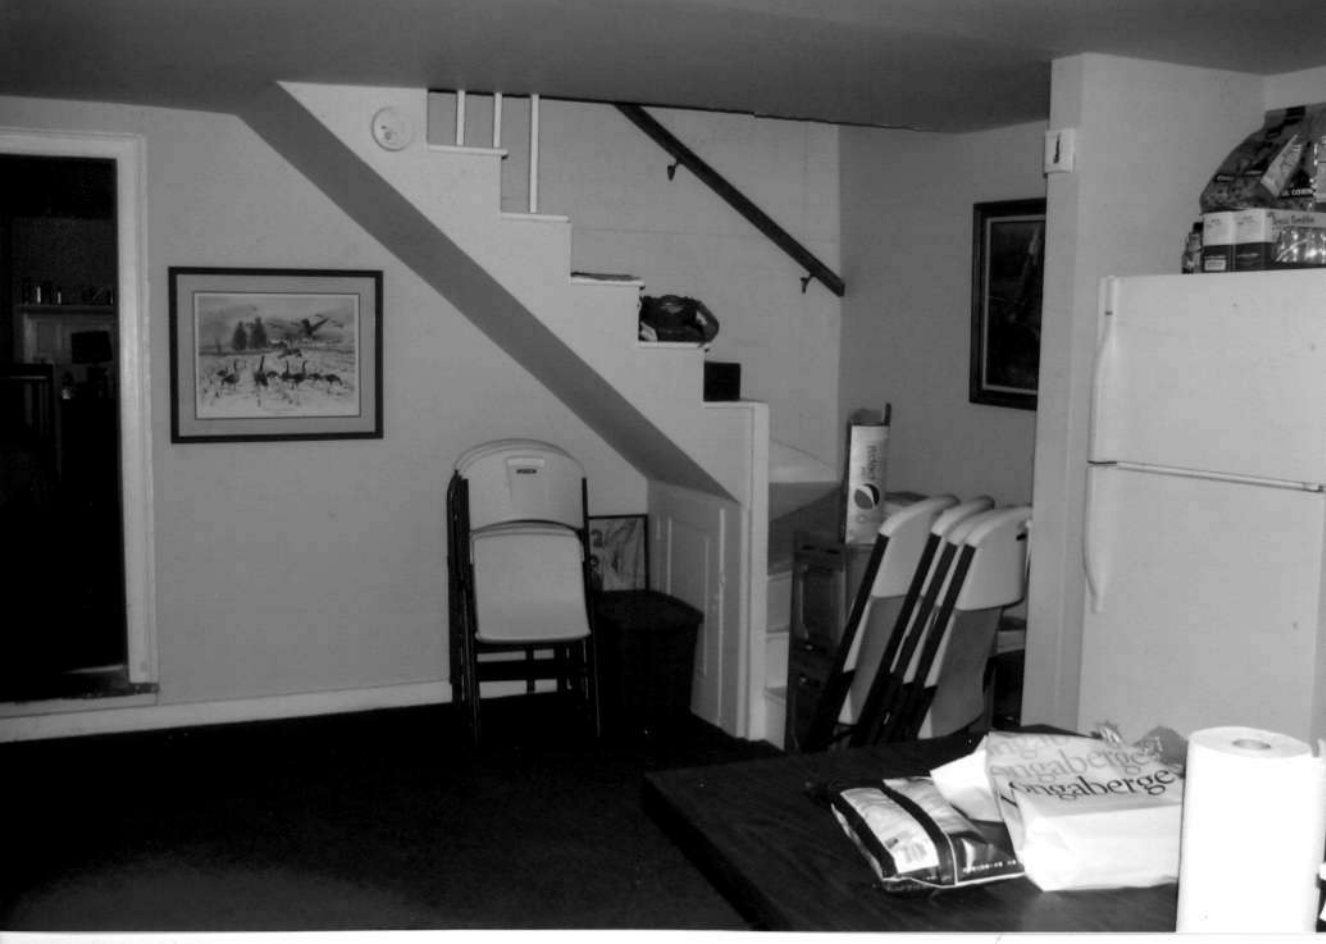
QA-0064_2010-10-26_06

South Elevation of Kitchen

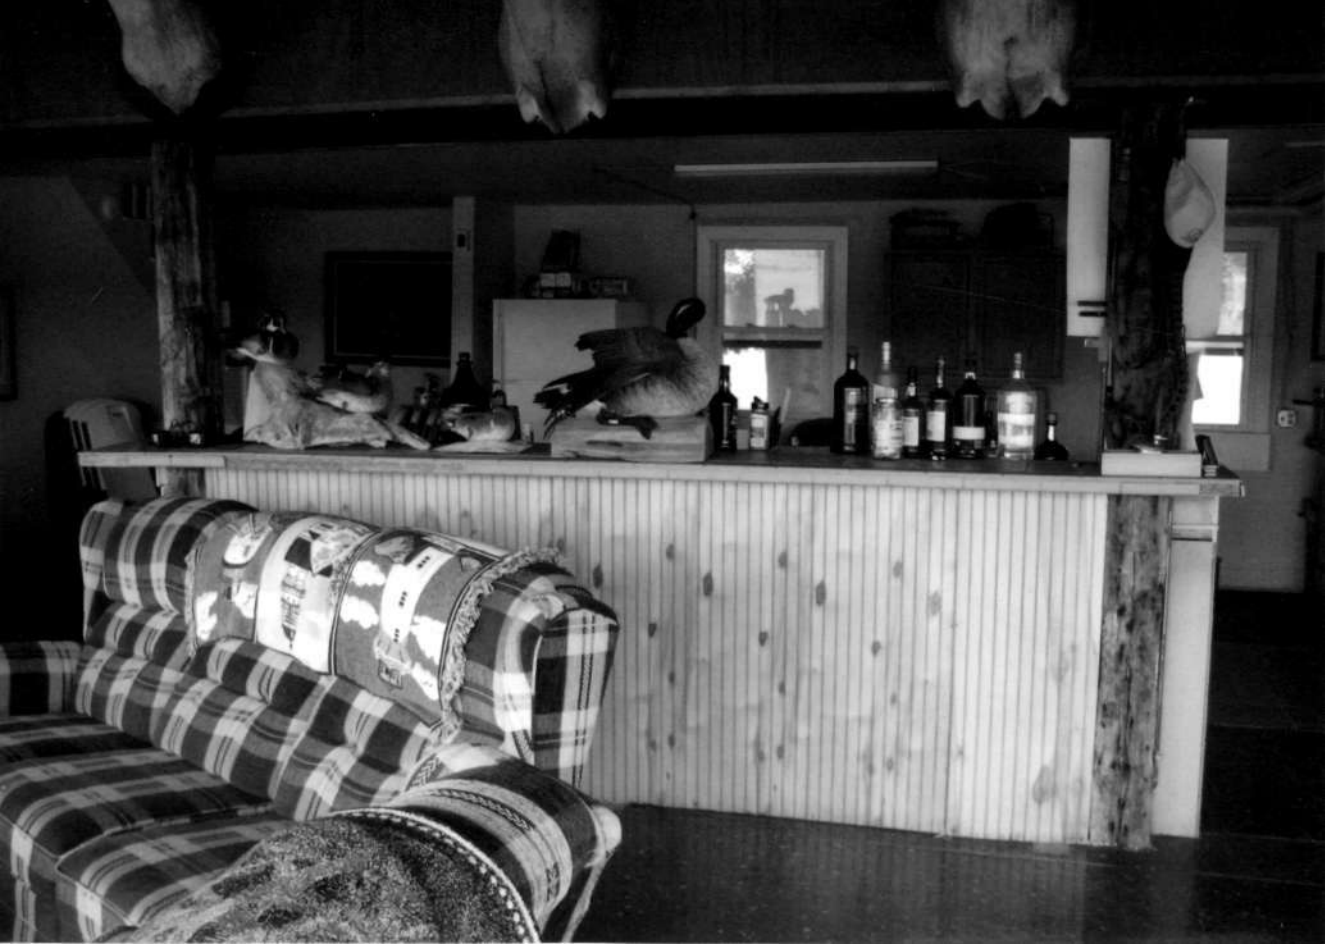
QA-0064_2010-10-26_07

New Room looking into Kitchen

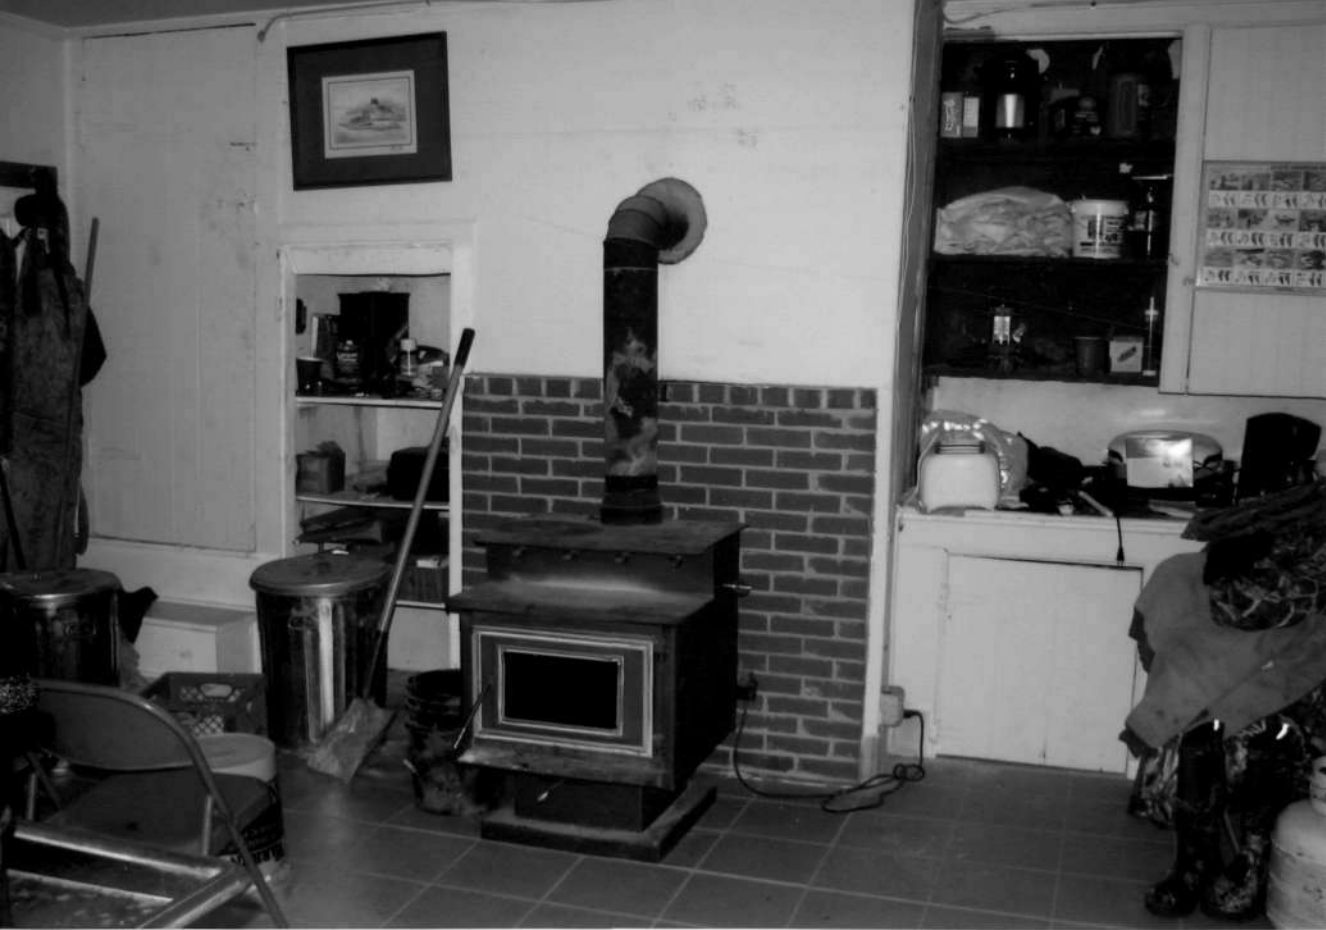
QA-0064_2010-10-26_08

Old Kitchen, North wall

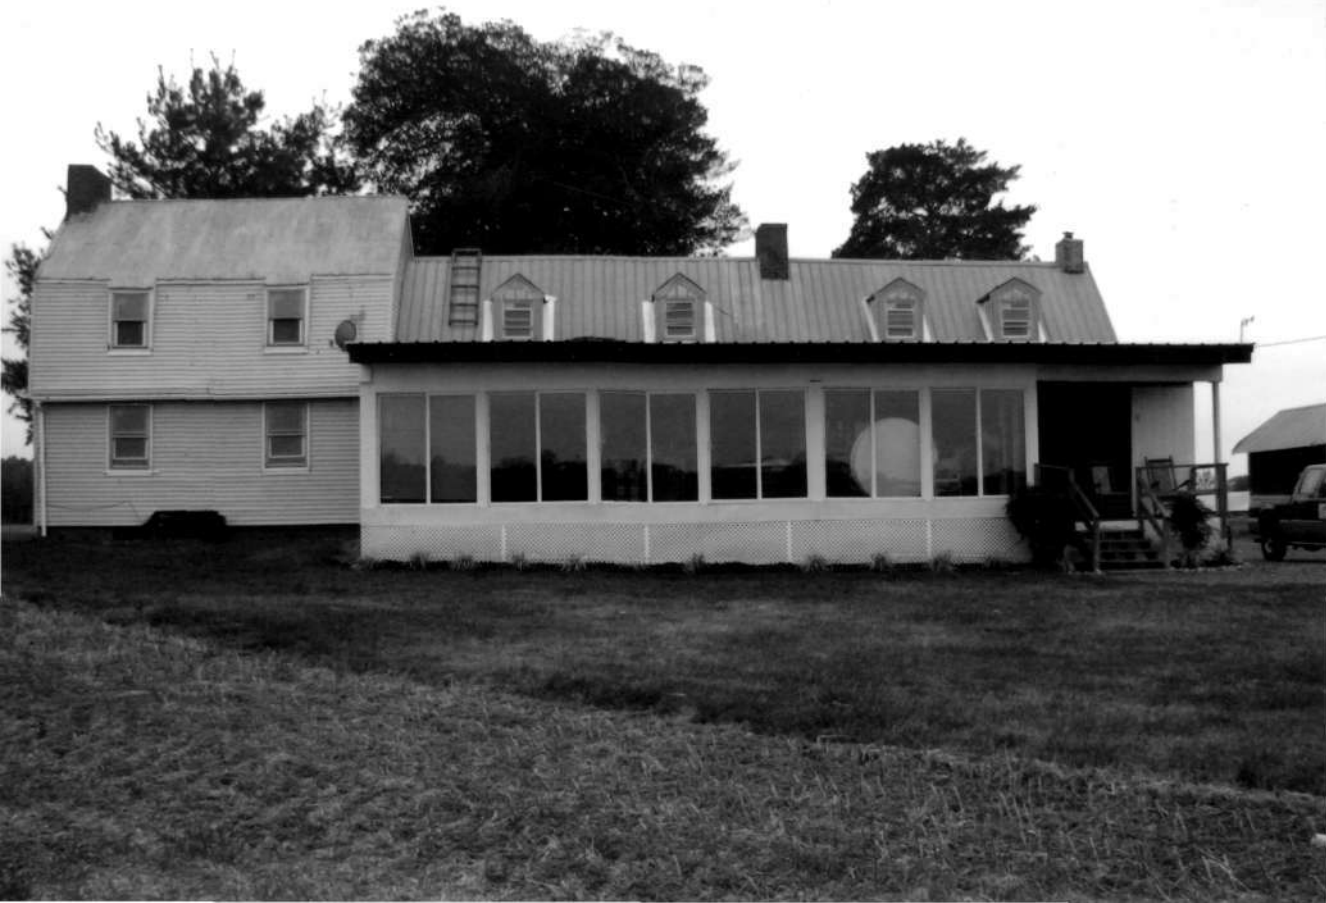
QA-0064_2010-10-26-09

Perhaps the largest change came when the lean-to addition on the east side was demolished and replaced with another larger addition that is twice as long and twice as deep as the original. It extends from the gambrel roof section to the north end of the house and contains sliding glass doors and an open porch. The only original window remaining on the house is in the open porch.

East Elevation

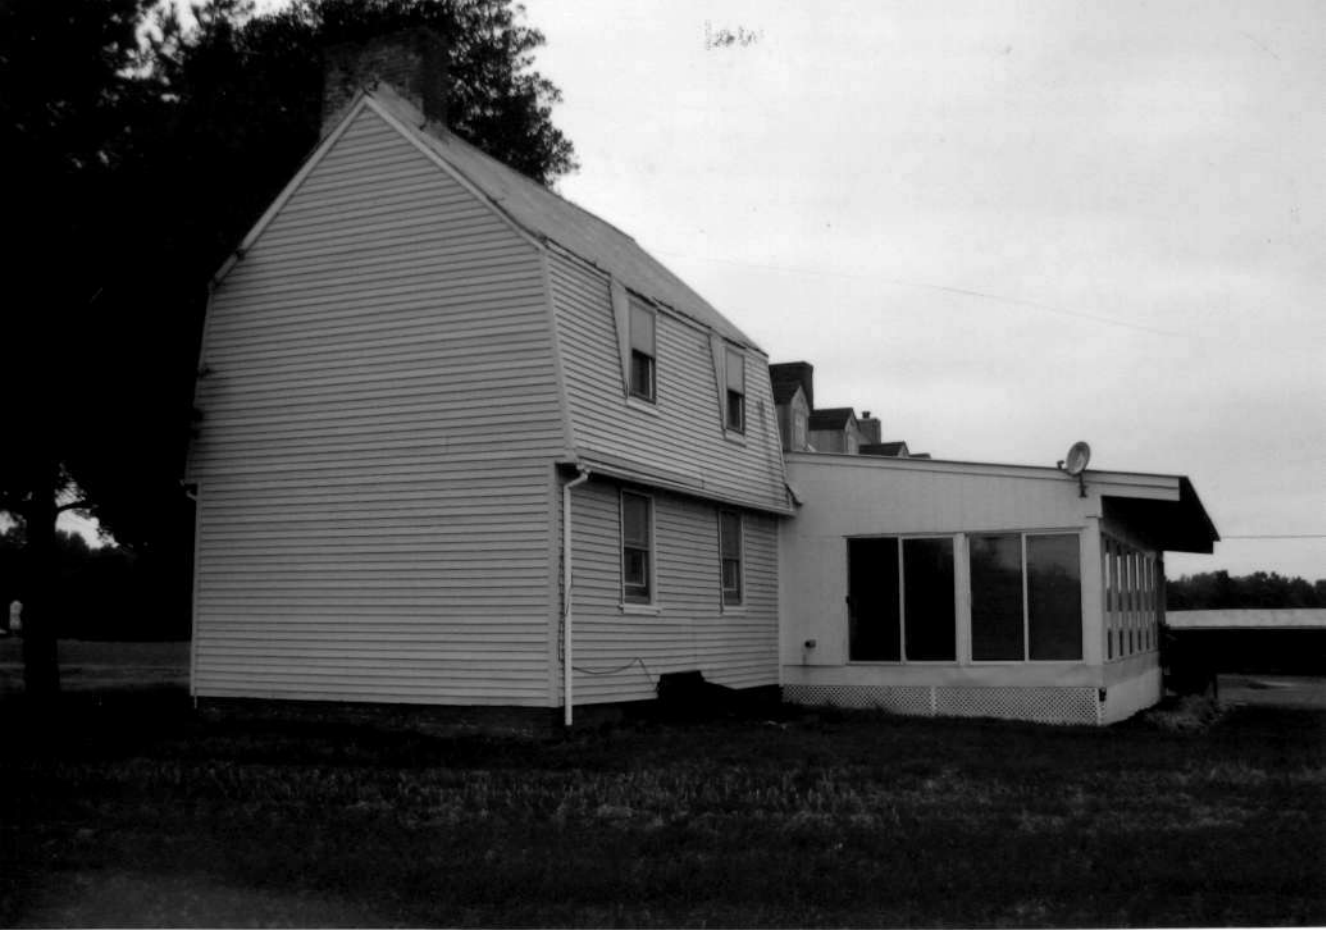
QA-0064_2010-10-26-10

South Elevation

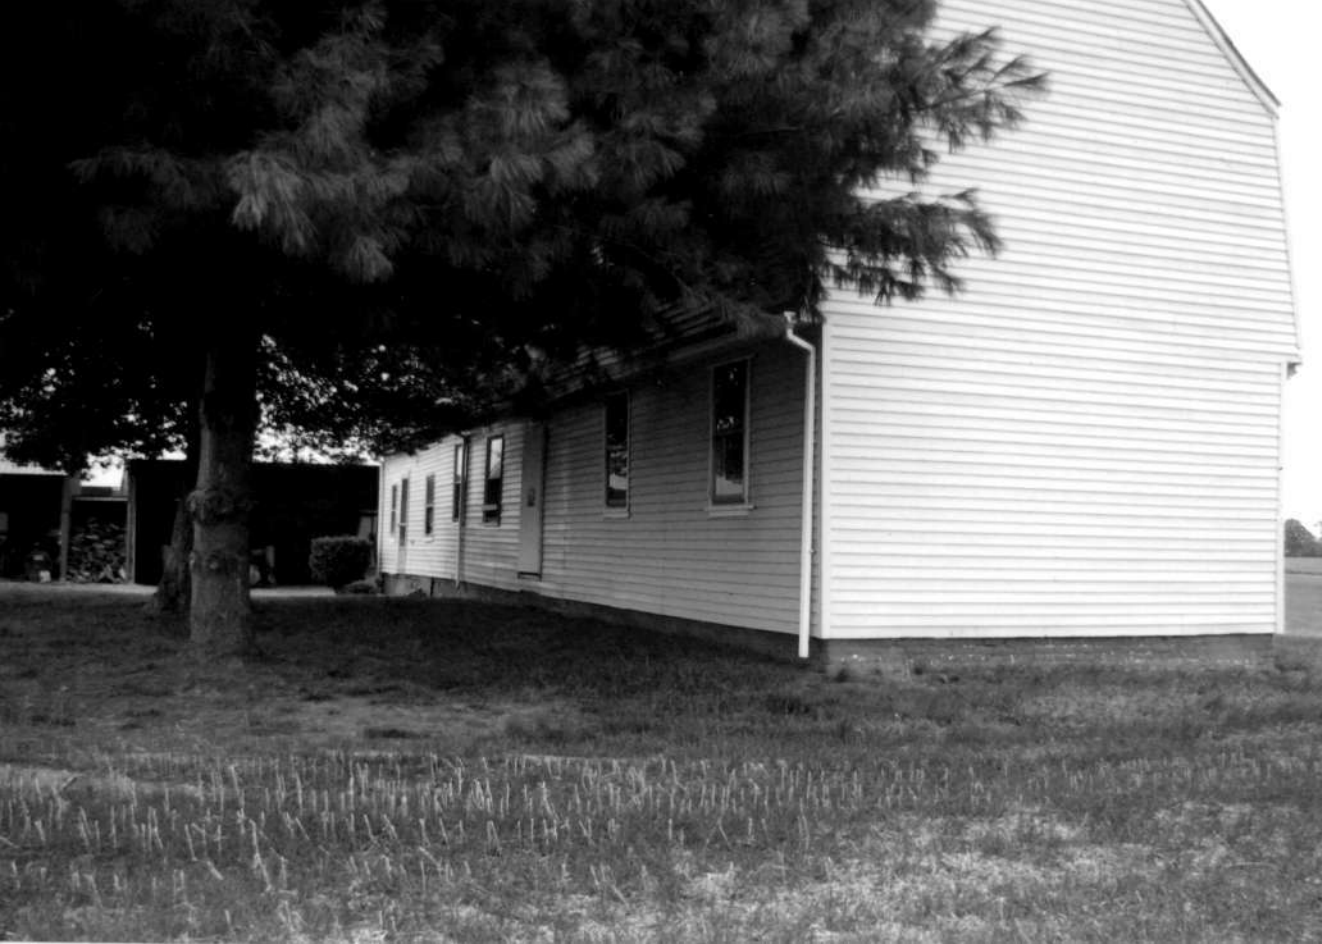
QA-0064_2010-10-26_11

View of West wall from South

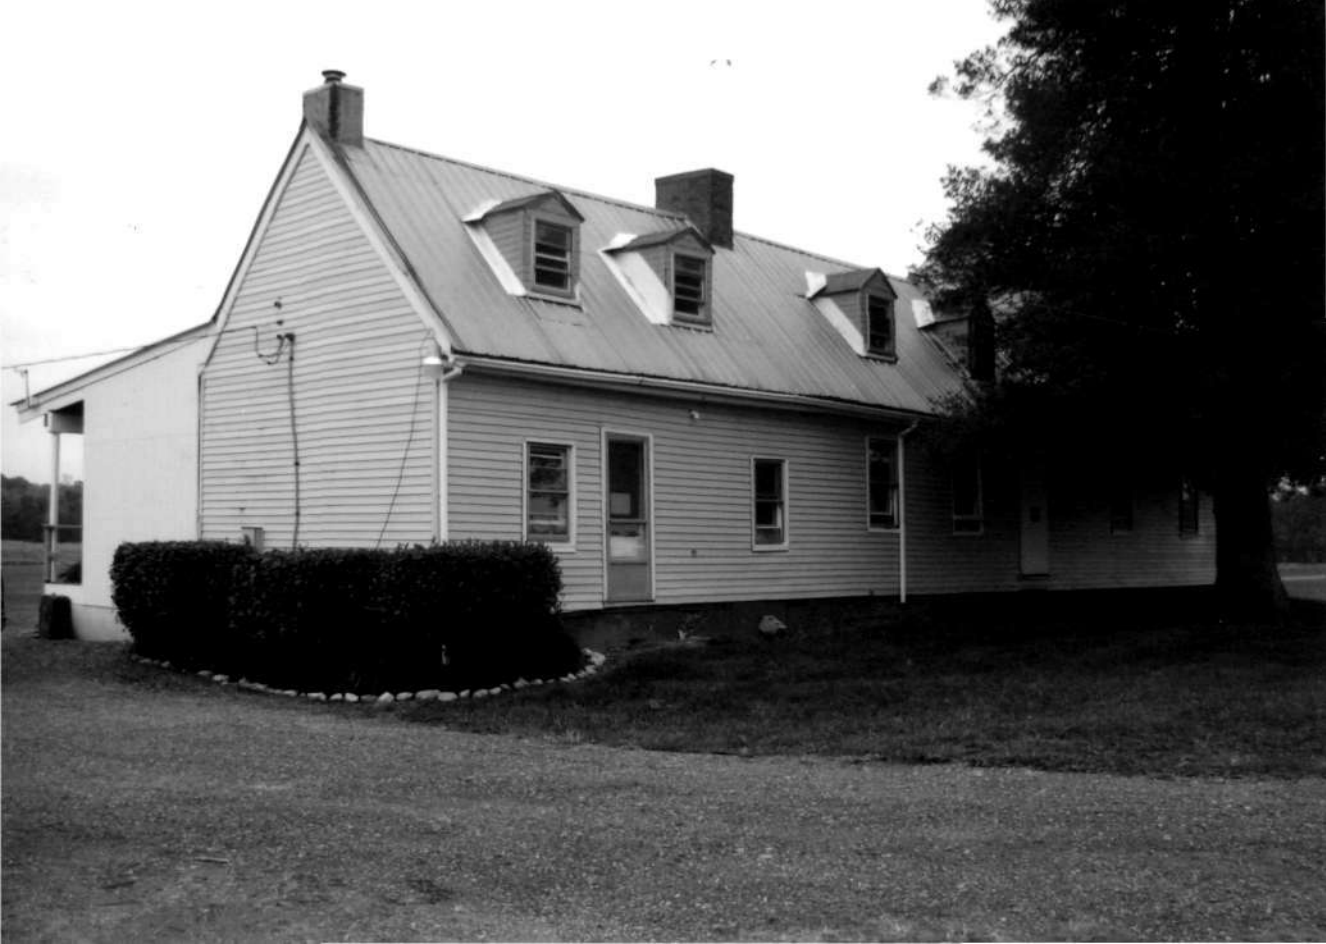
QA-0064-2010-10-26-12

VIEW FROM N.W.

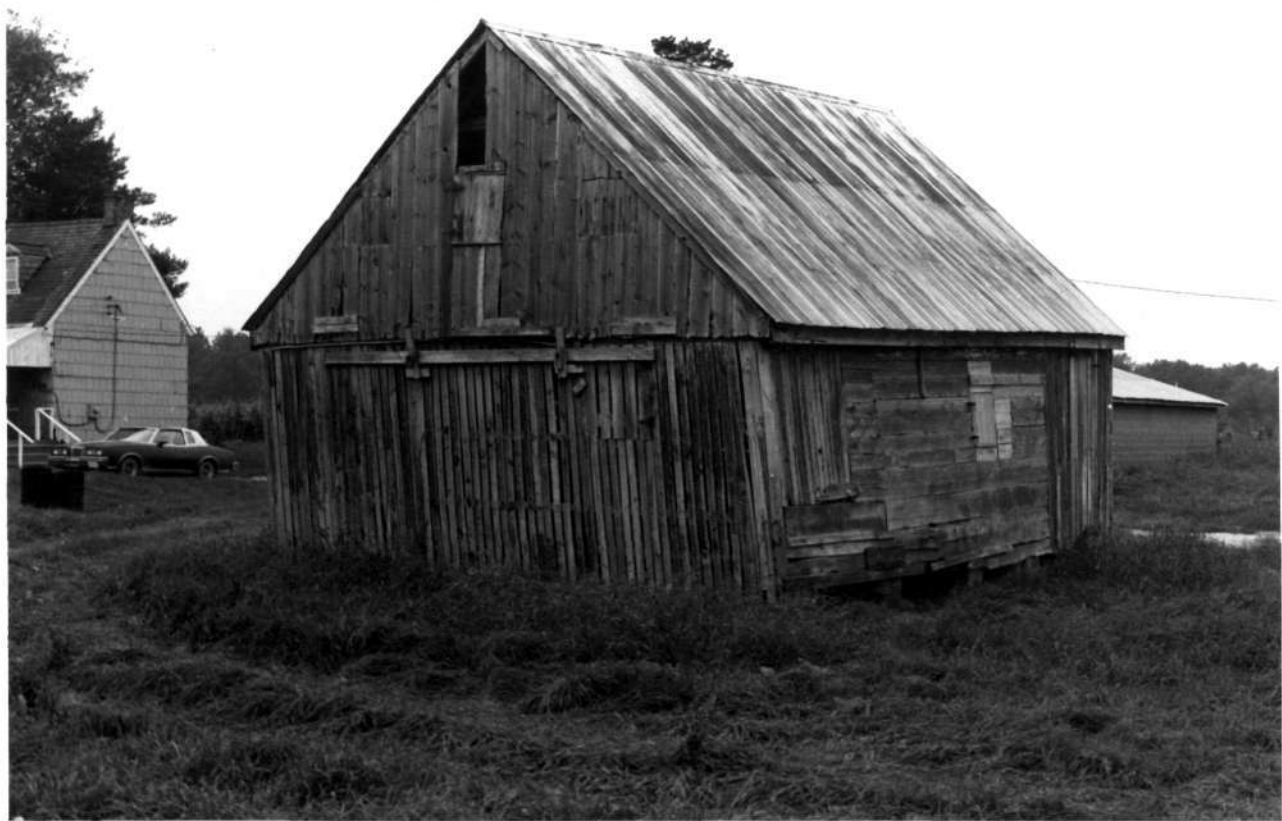
QA-64

Of perhaps greater significance is the combined granary/crib to the northeast of the house. This heavy timber frame building may be an early tobacco house renovated to store grain and corn. The overall dimensions of 24 feet by 32 are typical of small tobacco houses and divide into the four foot bays necessary to hang tobacco. Framing evidence, particularly in the roof, reinforces this conclusion. The presence of wrought nails suggests an 18th century building, a rare survival among farm buildings on the Eastern Shore.

Merrick Farm
Brierly Mill Road
Ingleside vicinity
Orlando Ridout V 1979
Granary
